# **Suffolk, VA. Fire & Rescue**

## **Near Miss Injury Report**

**Two Firefighters Injured by Wall Collapse  
during a Residential Garage Fire**

**144 Five Mile Road**

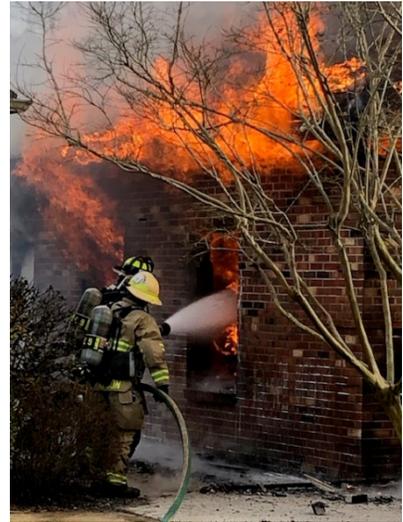
**Fire ground photo**

Crews arrived on scene to find heavy fire showing from 25' x 40' detached garage. There was an approximately 8-foot walkway separating the home from the garage. The fire was already encroaching on the main home and entering through the soffits. There were two automobiles in front of the garage, which were also beginning to burn, as well, as another home on the Delta side, which sustained minor thermal damage.

Crews had been operating for about 8 minutes when a wall collapsed, pinning the Lieutenant beneath the rubble. A subsequent “MAYDAY” was transmitted and crews sprang into action.

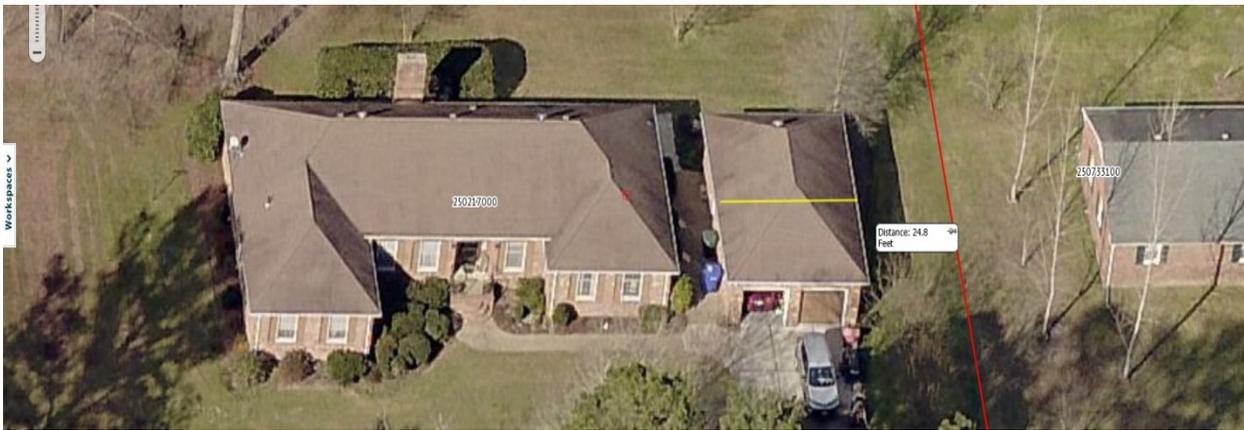
**144 Five Mile Road (aerial view)**

The incident occurred outside of the detached, residential garage built in 1973. The 1 ½ story, 25' x 40', 2 car garage featured approximately 989 square feet of space, 2 separate garage doors and upstairs storage space supported by a full length (~25') steel I-beam. Both the home and the garage were type 5 building construction with a brick veneer finishing.

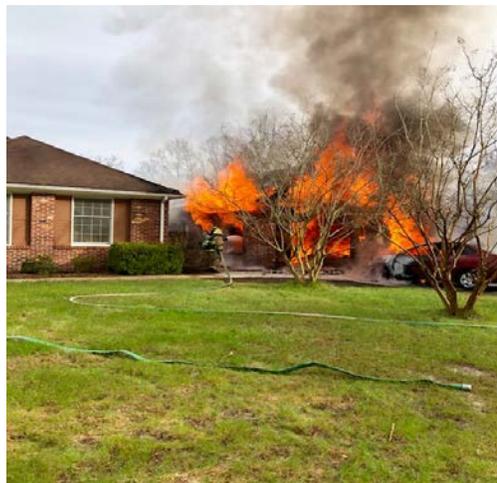
First line placed into operation

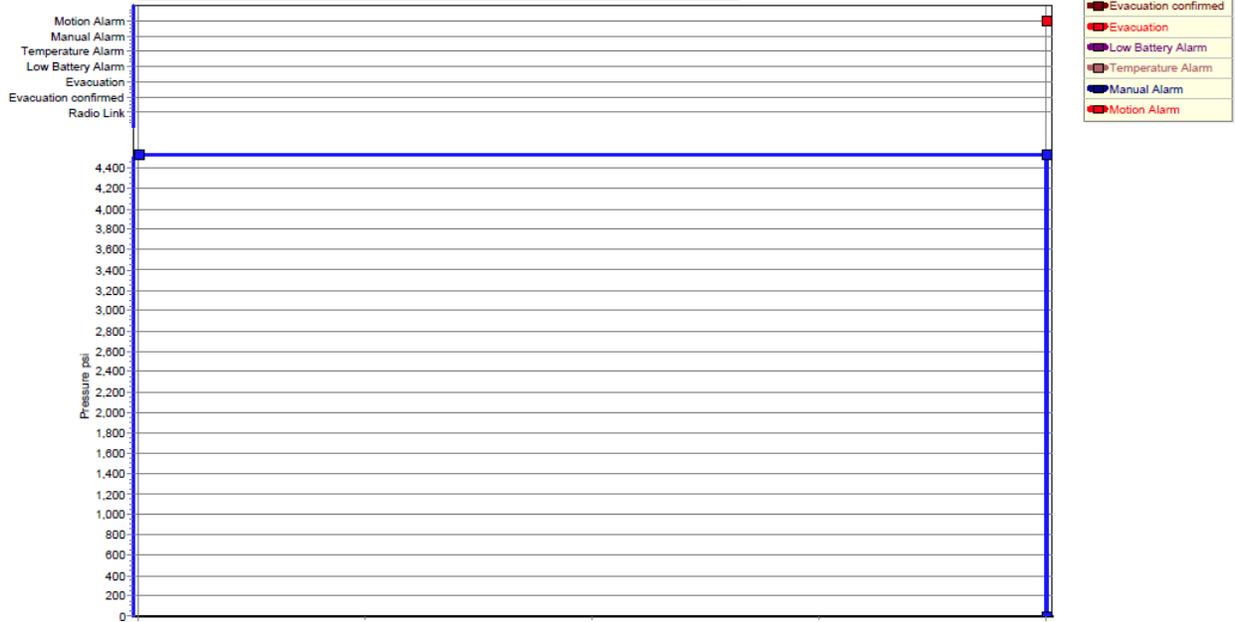
Session: 11 Mar 2019 07:35 - Duration: 2 minutes - Name: Officer  
 Serial #: 4536607  
 Cumulative pressurizations: 407  
 Cumulative Time: 796 minutes

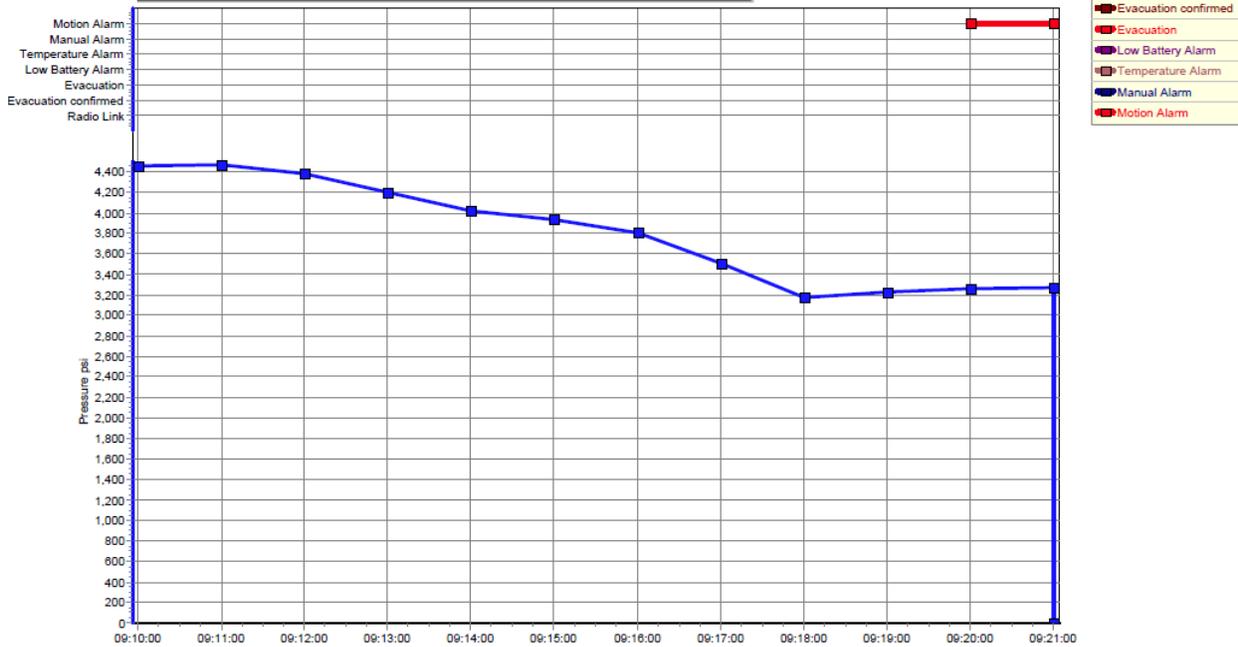
*AT 0910 hours on 03/11/2019 the unit was turned on with just over 4400 PSI of air in the unit. The data shows regular breathing until 0918 hours. The data shows no air usage from 0918 until 0921. The unit had about 3400 PSI of air. At 0920 hours the motion alarm activated. The unit was turned off at about 0921 hours.*

Session: 11 Mar 2019 09:10 - Duration: 12 minutes - Name: Officer  
 Serial #: 4536607  
 Cumulative pressurizations: 407  
 Cumulative Time: 796 minutes
