**City of Suffolk  
HISTORIC LANDMARKS COMMISSION**

**January 9, 2020**

**AGENDA**  
Historic Landmarks Commission Meeting  
Thursday, January 9, 2020  
9:00 a.m.

Subject: **REQUEST FOR CERTIFICATE OF APPROPRIATENESS HLC2019-00038**, submitted by Ben Clay, applicant and property owner, for exterior material alterations and window replacement on property located at 130 Brewer Avenue. The affected area is further identified as Zoning Map 34G17, Block 2 B, Parcels 18, 19, and 20, Suffolk Voting Borough, zoned CBD, Central Business District, and HC, Historic Conservation Overlay District.

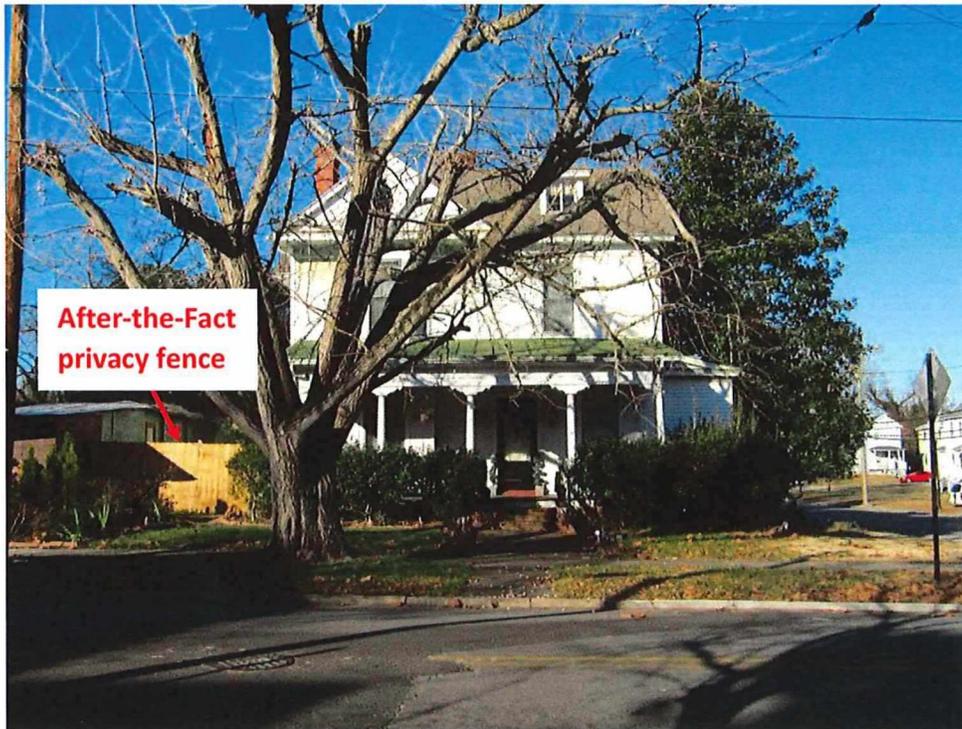
HLC2018-00026 237 Pinner Street

View from Pinner Street of the proposed location of the front yard black aluminum fence, walkway gate, and wooden fence along the eastern property

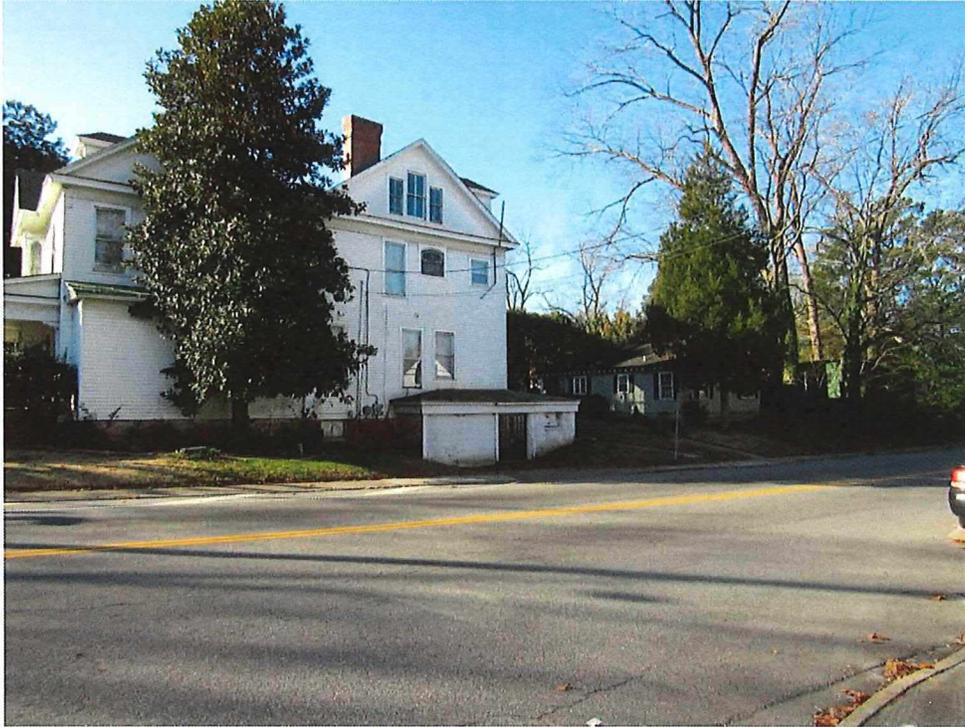
**HLC2018-00026 237 Pinner Street**

View from Finney Avenue of the northern side of the home where the proposed 4-foot tall black aluminum fence will be.

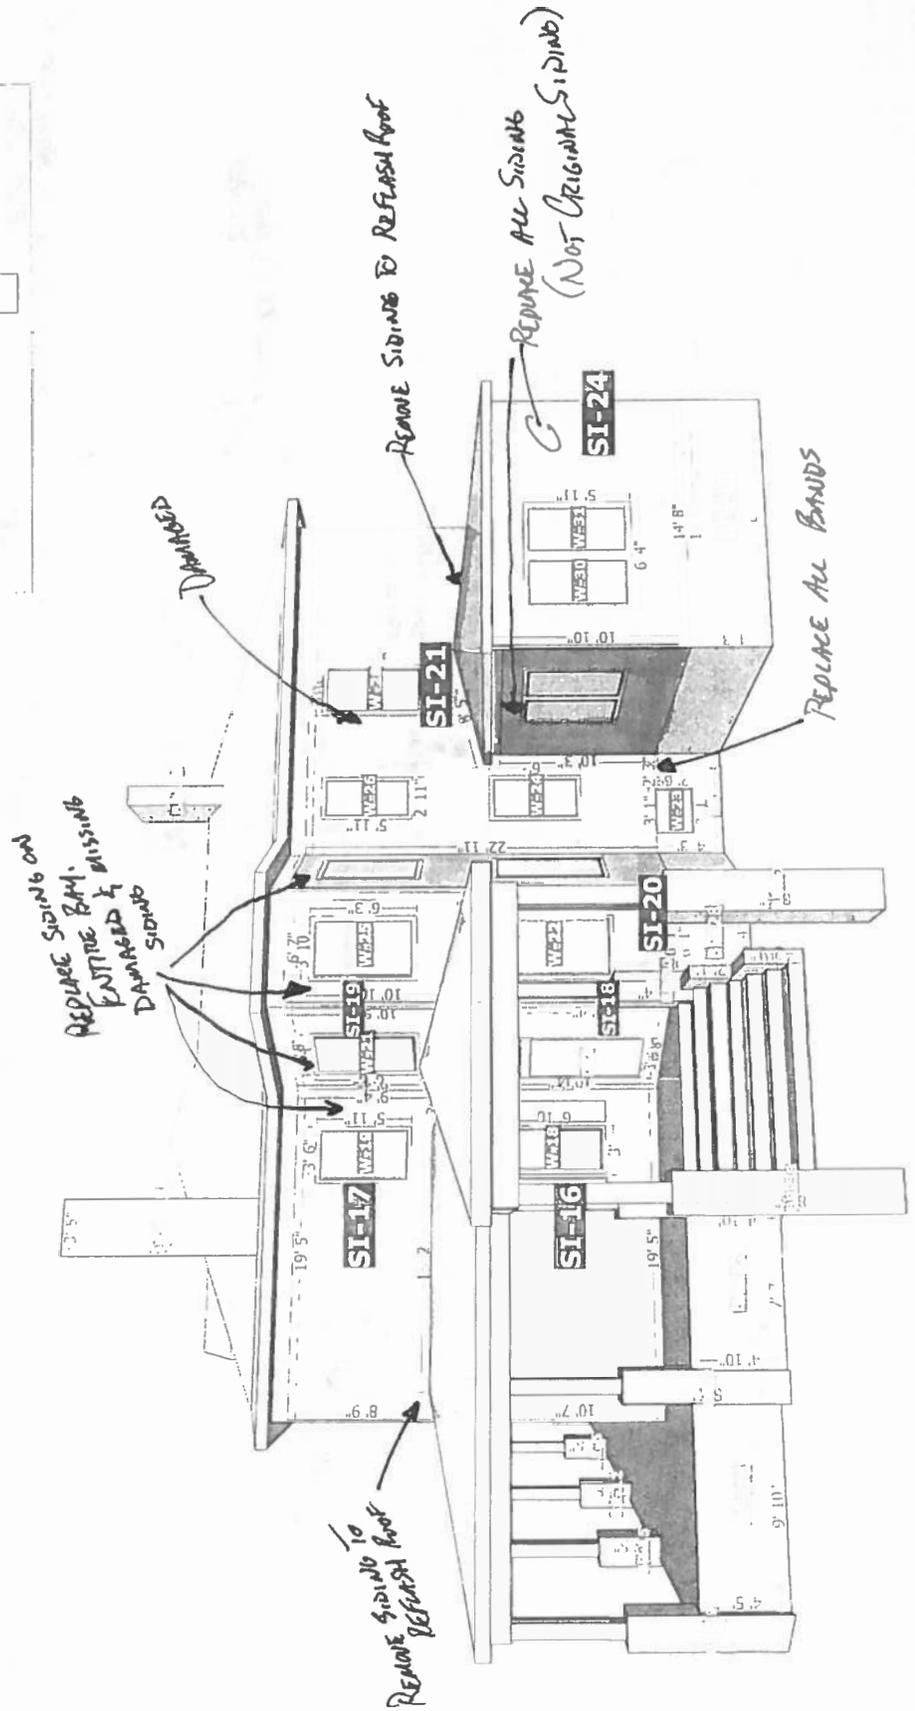
130 Brewer Ave, Suffolk, VA  
RIGHT

- Full wall damaged behind pipe
- Full wall of cupped/damaged siding
- Cracked/damaged outer edges all the way up
- Replace siding on entire band
- Behind all existing shutters damaged

RIGHT SIDE:  
Approx. 73% REPAIRMENT

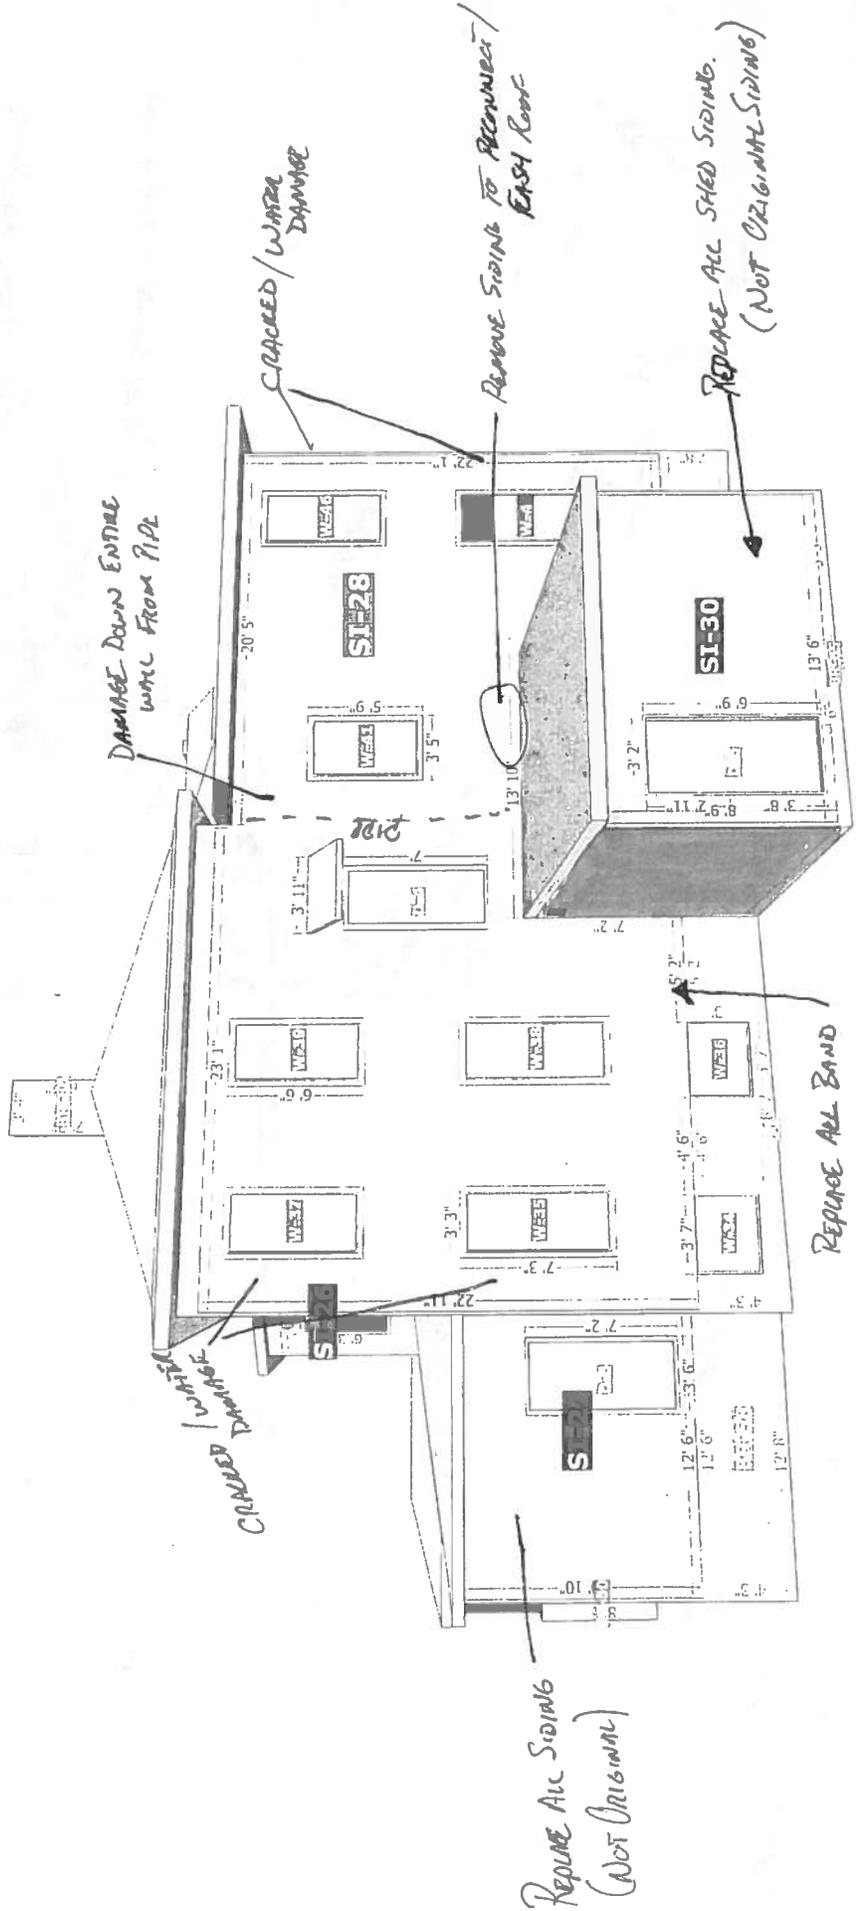
130 Brewer Ave, Suffolk, VA  
BACK

- Entire bay needs replaced; cracked boards and missing siding
- Replace all siding on "addition"; has non-matching siding
- Remove siding above addition roof to reflash
- Replace siding on entire band
- Behind all existing shutters damaged

REAR:  
APPROX. 76% REPAIRMENT

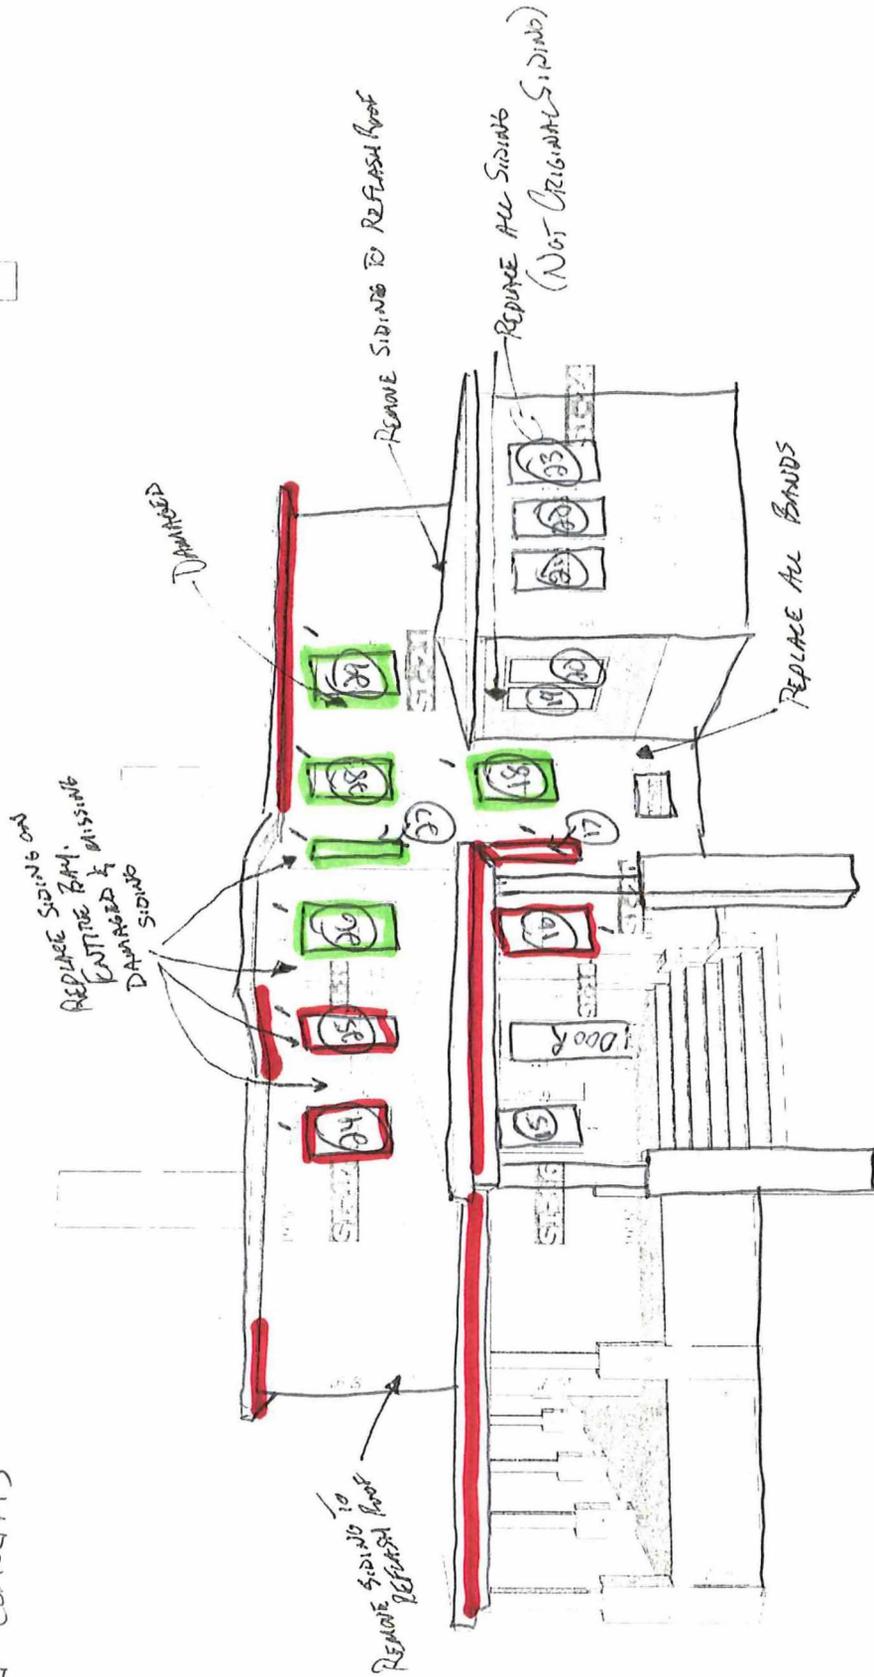
- The majority of all dental molding and block is rotten or falling off the home. There are even sections where the dental blocks are missing.
- To properly install the water vapor barrier behind the siding, all of the molding and siding needs to be removed all the way up to the underside of the gutter.
- The dental block and molding will be replaced with a Hardi brand material. This will ensure that it will not rot again. The sizes of the molding and dental block can be matched to the existing size and shape.

RIGHT SIDE: Dental Block/Molding/window trim  
Approx. 78% Replacement

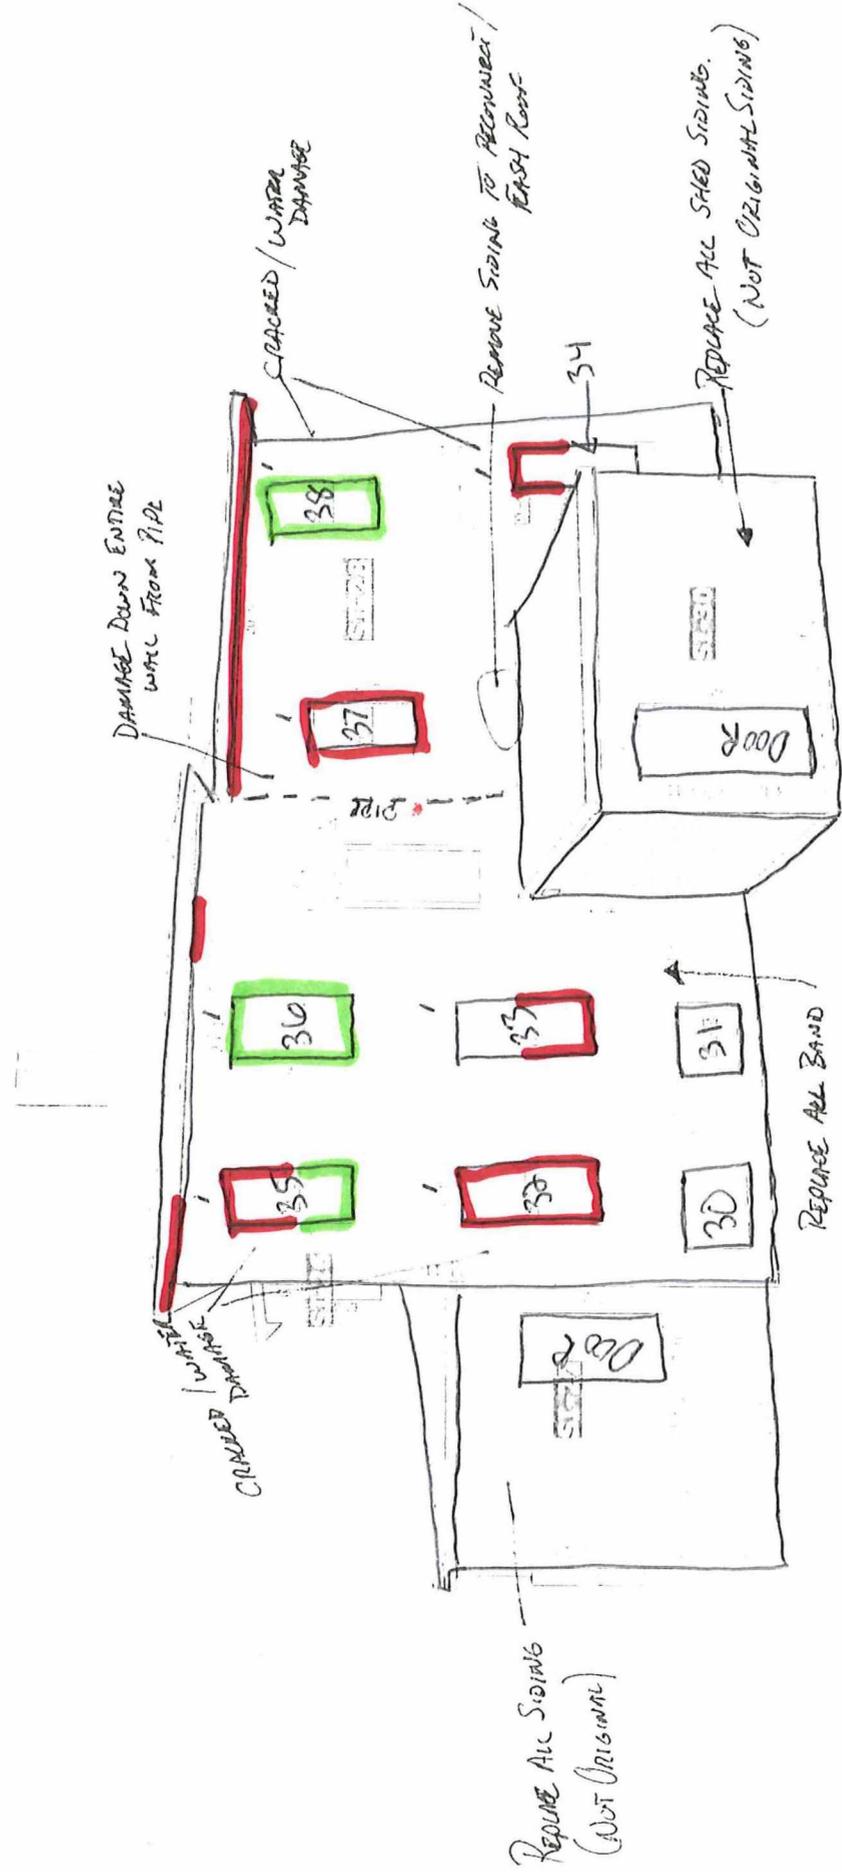
REAR: Dental Block/molding/window trim  
Approx. 70% Replacement
